Histopathological Study of Tissue Reaction to Pacemaker Electrodes Implanted in the Endocardium

(J Nippon Med Sch 2005; 72: 52-59)

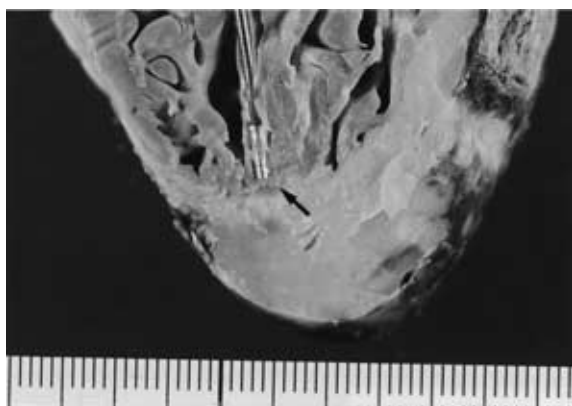
Fig. 1 The electrode is deeply implanted at the apex of the right ventricle and is tightly attached to the endocardium (**arrow**) (Case 12).

The electrode was deeply implanted at the apex of the right ventricle in all patients. There were two patterns of contact between the electrode and the endocardium: tight contact (**Fig. 1**) and loose contact (**Fig. 2**).

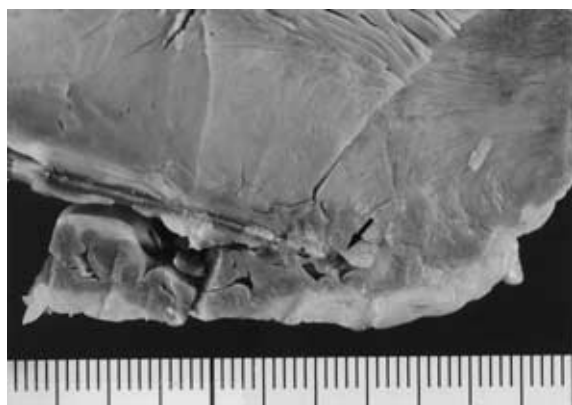
Fig. 2 A space (**arrow**) is found between the tip and the endocardium (Case 5).

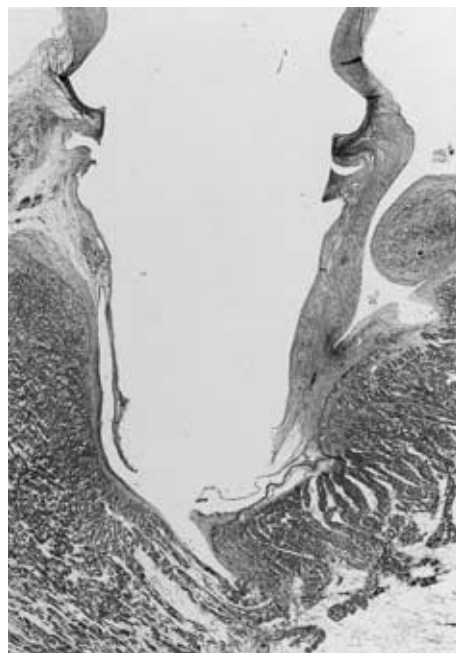
Fig. 3 The electrode is in tight contact with the endocardium and no reactive endocardial thickening is observed in the contact area (Case 11, EMG stain).

In one patient in whom the pacing electrode had been implanted sixteen years and four months prior to death (Case 11), it was in tight contact with the endocardium and no reactive endocardial thickening was observed in the contact area (**Fig. 3**).

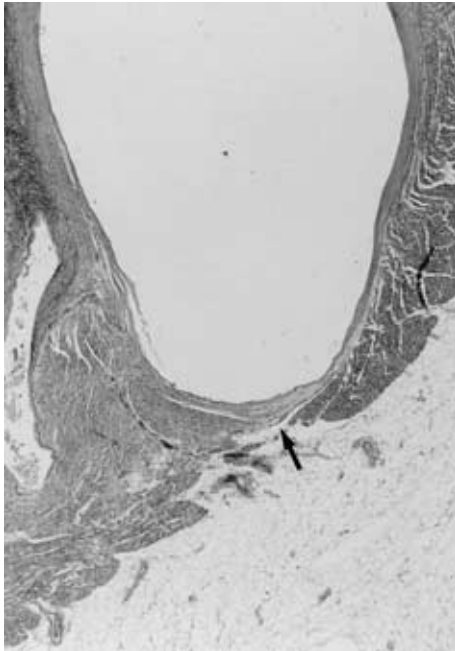
Fig. 4 Cardiomyocytes under the tip have disappeared and are replaced by fibrous connective tissue (**arrow**) (Case 7, H-E stain).

In the other patients with tight contact, cardiomyocytes under the tip had disappeared and had been replaced by fibrous connective tissue (**Fig. 4**). In one patient with eight years and seven months of PM implantation (Case 9), fibrosis was observed as a result of the disappearance of cardiomyocytes on one side of the tip. In addition, the fibrotic tissue was formed by an organized thrombus that included capillary proliferation (**Fig. 5-a, b**).

In our cases with tight contact, cardiomyocytes under the tip had disappeared and been replaced by fibrous tissue. This fibrous connective tissue acts as a virtual electrode and does not usually affect the threshold¹⁵⁻⁸. However, in one case where the electrode had been inserted into the thin wall area of the right ventricle, the layer of cardiomyocytes had disappeared completely, and only the adipose tissue of the epicardium surrounded the tip, leading to a possible increase in the pacing threshold. Patients who have an apex with extremely thin endocardium should not have electrodes inserted into it.

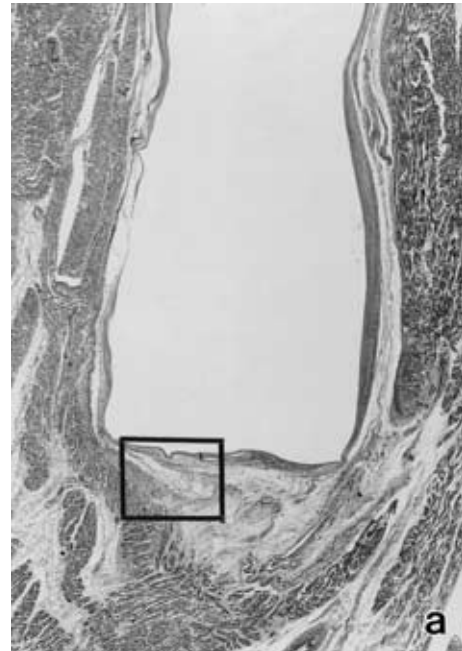
Fig. 5-a Fibrosis results from the disappearance of cardiomyocytes on the left side of the attachment area (Case 9, EMG stain).

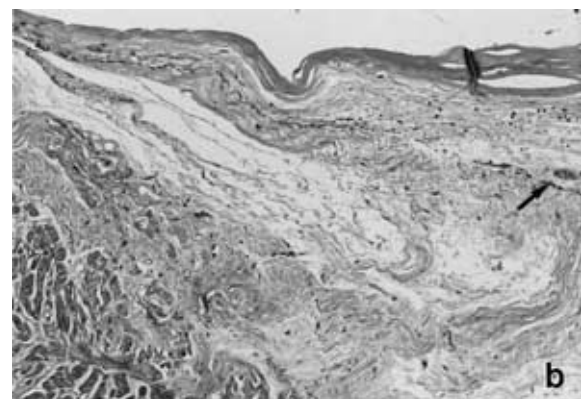
Fig. 5-b A higher magnification view of **a**. Fibrotic tissue is formed by an organized thrombus including a capillary (**arrow**) on the right side of the attachment area, suggesting a small space remained after the electrode insertion (Case 9, EMG stain).

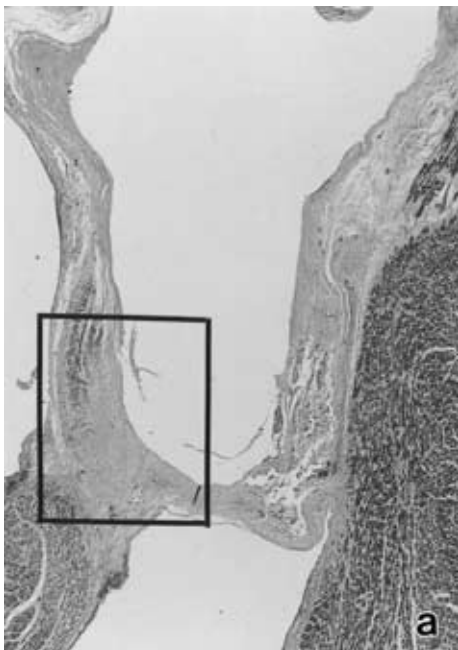
Fig. 6-a A fibrous sheath covering the electrode extends to the tip and forms a thick fibrous cap (Case 5, EMG stain).

In the three patients (Case 1, 5 and 13) with loose contact between the electrode and the endocardium, a space was seen between the tip and the endocardium. A fibrous sheath covering the electrode extended to the tip, and it formed a thick fibrous cap (**Fig. 6-a, b**). A few capillaries were found in the sheath (**Fig. 6-c**).

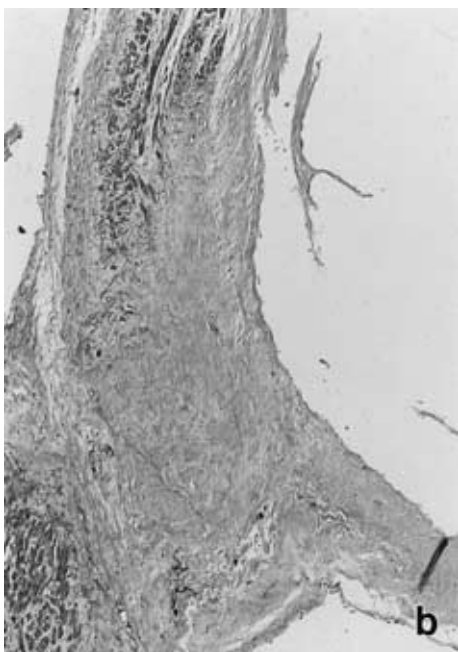
Fig. 6-b A higher magnification view of a (Case 5, EMG stain).

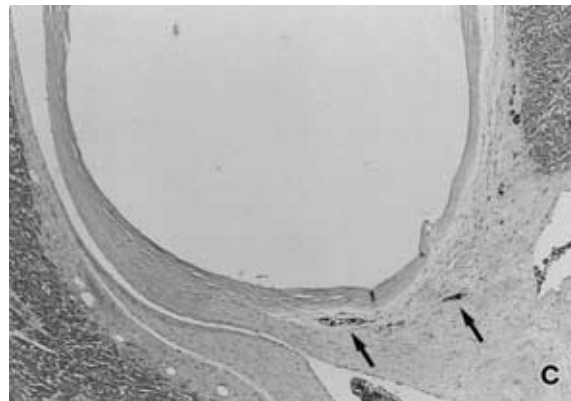
Fig. 6-c A few capillaries (**arrows**) are found in the sheath (Case 13, H-E stain).

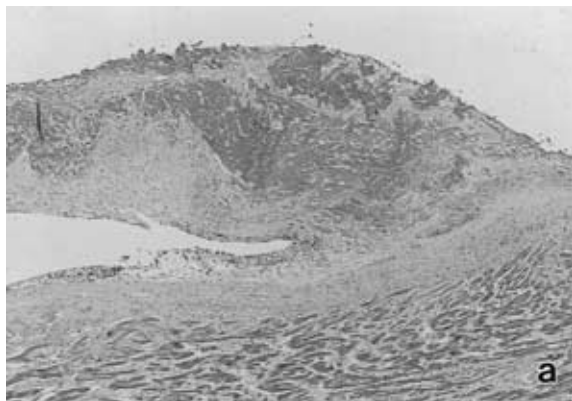
Fig. 7-a In the early period after implantation, the electrode is covered with a fibrin thrombus (Case 1, H-E stain).

In one patient with a short period of implantation (Case 1), a fresh fibrin thrombus was formed on the tip of the electrode. An organized thrombus was observed around the fin in the other patient (Case 6) and the process of organization of these thrombi turning into a fibrous sheath was observed in other patients with a relatively long period of implantation (**Fig. 7-a, b, c**). In all the long-term implantation cases, the pacemaker electrodes were completely covered with fibrous sheaths from lead to tip (**Fig. 8**).

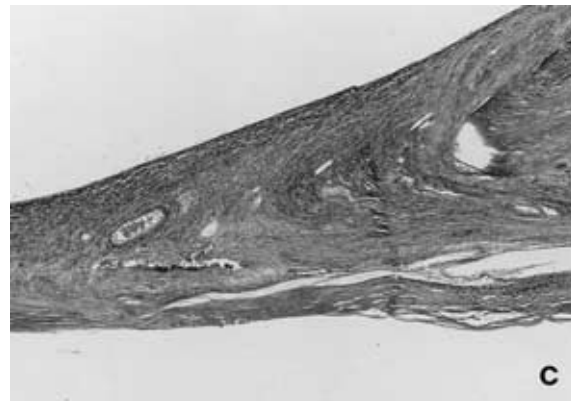
Fig. 7-c The granulation tissue matures into a fibrous sheath consisting of collagen fiber (Case 7, EMG stain).

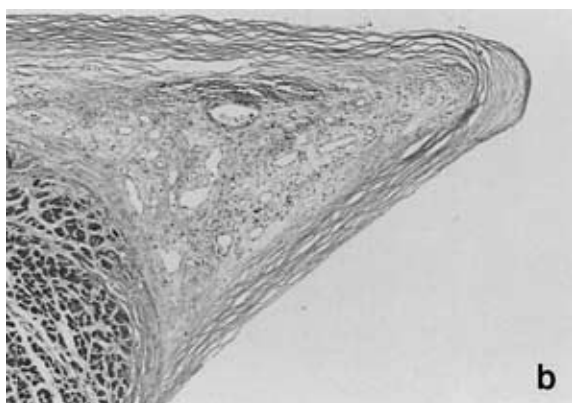
Fig. 7-b The granulation tissue of the organized thrombus is observed between the electrode and the endocardium (Case 6, EMG stain).

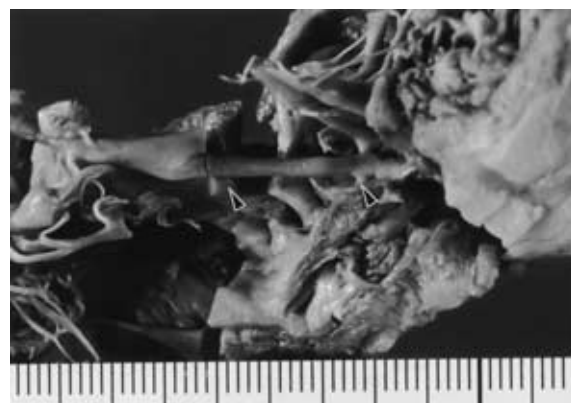
Fig. 8 The pacemaker electrode is completely covered with a fibrous sheath from the lead to the tip (**arrowheads**) (Case 10).

fibrous sheath formed an organized fibrin thrombus, which initially adhered to the surface of the tip. The whole length of the PM leads was covered with this sheath in the patients with long periods of implantation.
