## Fracture of an Expandable Metallic Stent Placed for Biliary Obstruction due to Common Bile Duct Carcinoma

We report our second case of fracture of a SMART self-expandable metallic stent (Cordis Endovascular, Warren, NJ) placed to treat biliary obstruction due to an unresectable common bile duct carcinoma. An 82-year-old man presented with jaundice. Computed tomography and ultrasonography on admission demonstrated a mass in the lower common bile duct. The mass was identified as a common bile duct obstruction. A SMART stent was inserted. Ten months after stent insertion, two additional SMART stents were inserted to relieve obstructive jaundice due to occlusion of the first stent. Fourteen months after insertion of the first stent, endoscopic examination revealed stenosis of the duodenum due to invasion of the common bile duct carcinoma, prompting us to perform a gastrojejunostomy 1 month later. Three months after gastrojejunostomy, the patient presented with obstructive jaundice and cholangitis. A fracture of one of the stents was then discovered on plain X-ray films and percutaneous transhepatic cholangiography. Two SMART stents were inserted simultaneously. In conclusion, we re

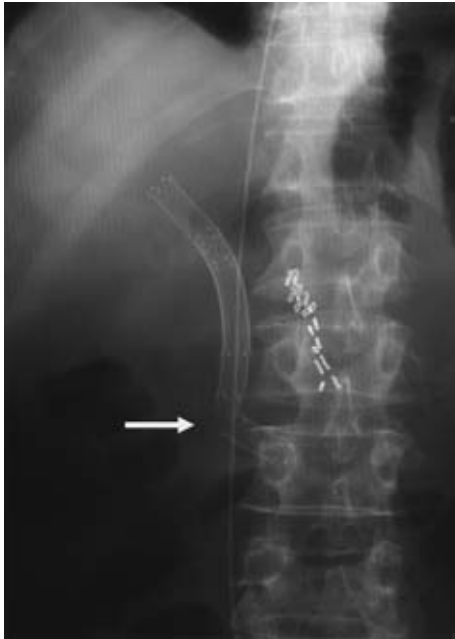
Fig. 1 Plain X-ray film showing the stent fracture (arrow).

In November 2004 the patient presented with jaundice and pyrexia. Computed tomography and ultrasonography revealed dilation of intrahepatic bile ducts, and a fracture of one of the stents was discovered on plain X-ray films (**Fig. 1**). Percutaneous transhepatic cholangiography demonstrated fracture of the stent at the papilla of Vater and obstruction due to tumor ingrowth (**Fig. 2**). During the procedure we placed two SMART stents measuring 10 mm (diameter)  $\times$  80 mm (length) with our one-step insertion technique<sup>2</sup>. The drainage catheters were left in place after surgery (**Fig. 3**) and were removed after stent patency was confirmed 3 days later.

Stent fractures have also resulted from treatments for tumor ingrowth such as balloon expansion<sup>27</sup> and laser therapy<sup>25</sup>. Fractures in cases without such treatments may result from metal fatigue<sup>28</sup> or the tearing of the polyurethane stent cover<sup>29</sup>. Because our patient received no other treatment, we presume that the fracture was related to metal fatigue from repeated bending in the duodenum.

The fracture was mostly likely caused by ongoing stress at the site of maximum leverage. To explain their experiences with fractured Memotherm stents, Peck et al.<sup>21</sup> have speculated that Memotherm stents might be stiffer than other bile duct stents and, therefore, fracture more easily by bending. The stent in our patient shifted to the left and anteriorly due to tumor growth and prolonged mechanical stress.

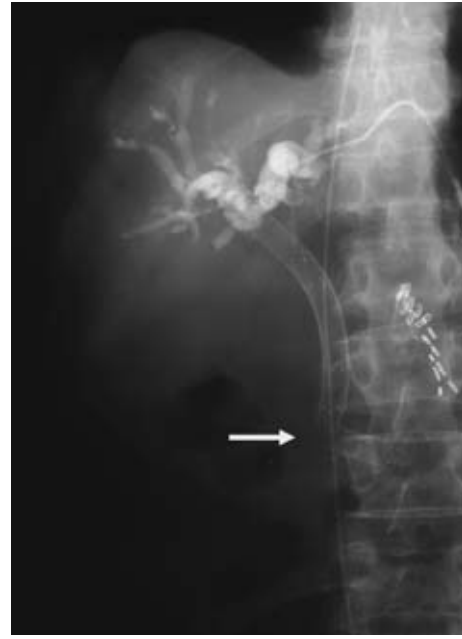
Fig. 2 Cholangiography demonstrating the stent fracture (arrow) at the papilla of Vater and obstruction due to tumor ingrowth.

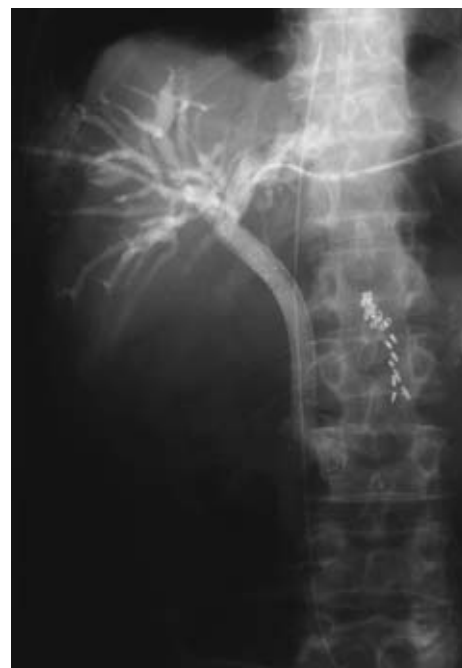
Fig. 3 Two 10×80-mm SMART stents were inserted simultaneously by one-step insertion, and the drainage catheters were left in place.
